# Plan of Box Roman Villa c. 350 AD

Drawn by Mark Corney and used with permission

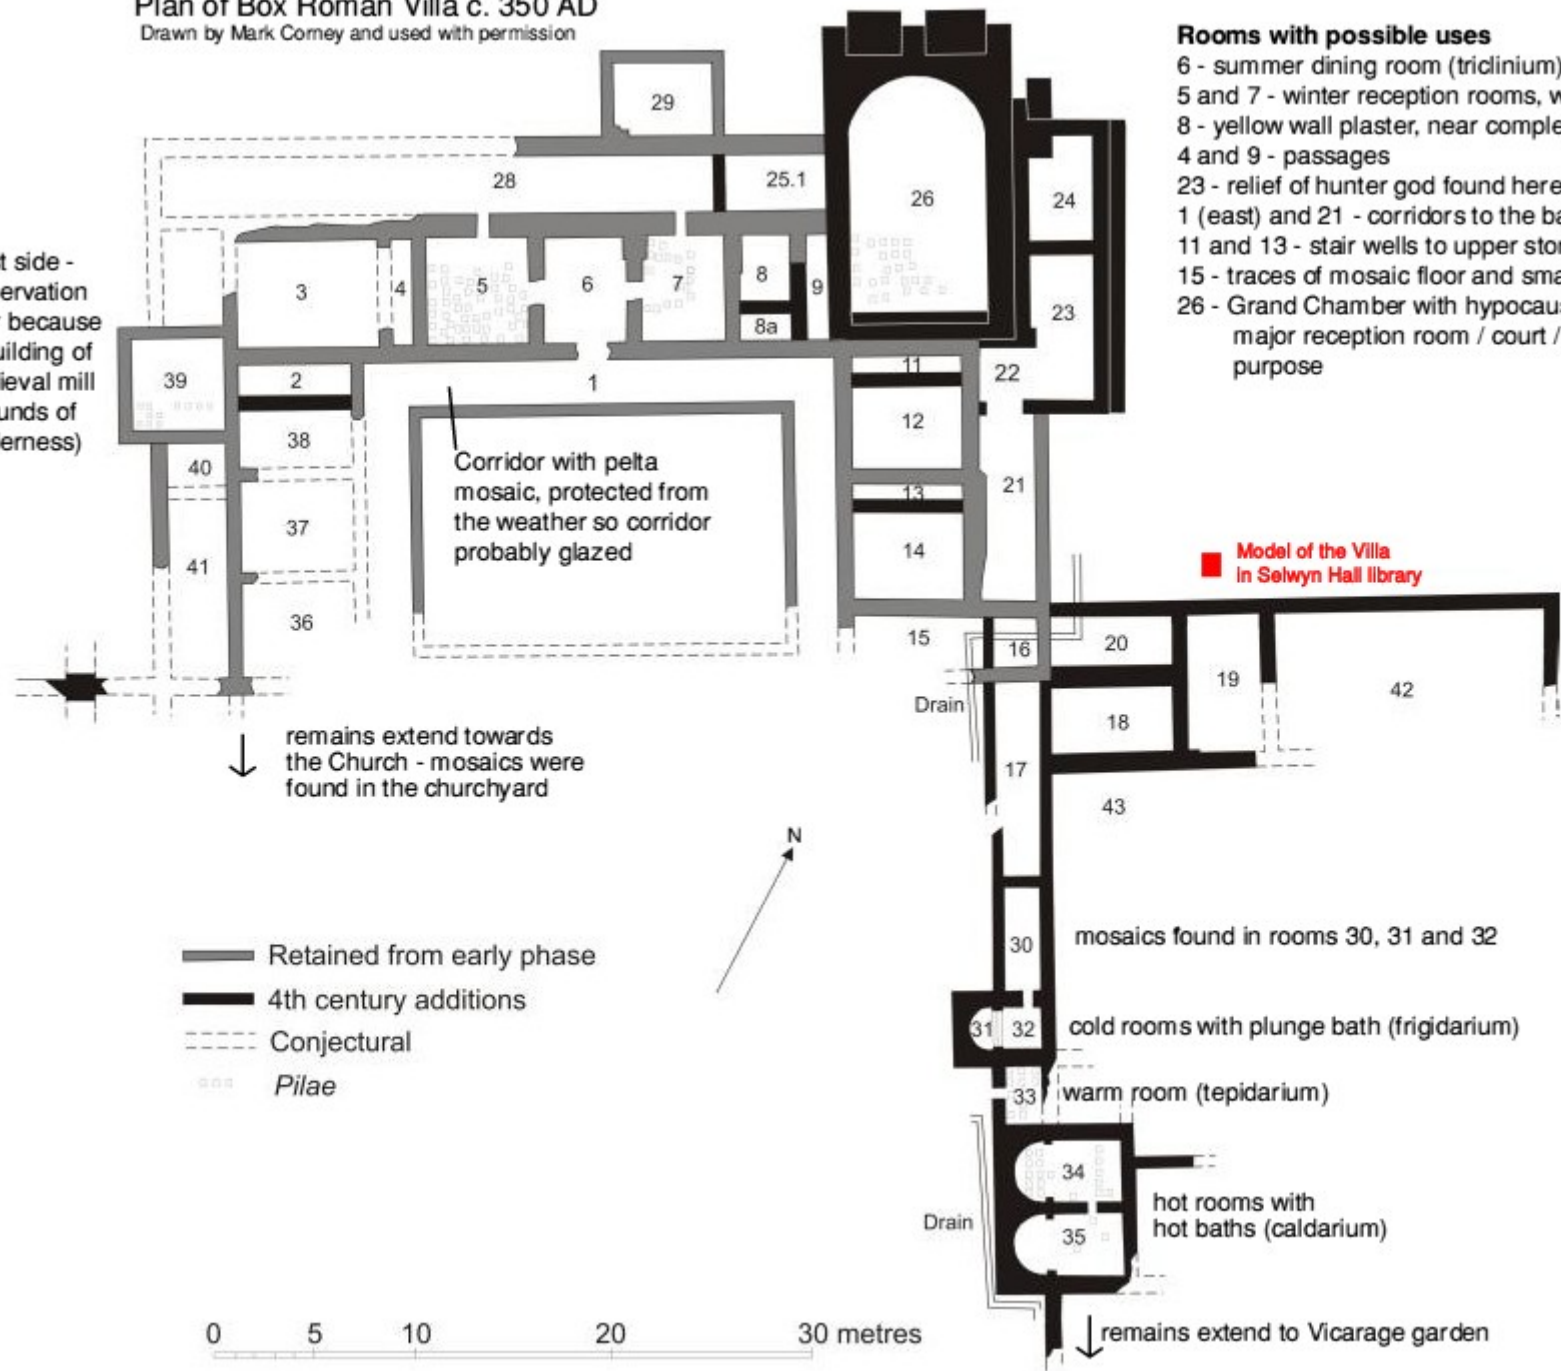
West side -  
preservation  
poor because  
of building of  
Medieval mill  
(grounds of  
Wilderness)

Corridor with pelta  
mosaic, protected  
from the weather so  
corridor  
probably glazed

remains extend towards  
the Church - mosaics were  
found in the churchyard

- 6 - summer dining room (triclinium)
- 5 and 7 - winter reception rooms, with hypocaust
- 8 - yellow wall plaster, near complete mosaic
- 4 and 9 - passages
- 23 - relief of hunter god found here
- 1 (east) and 21 - corridors to the baths complex
- 11 and 13 - stair wells to upper storey
- 15 - traces of mosaic floor and small stone altar
- 26 - Grand Chamber with hypocaust - major reception room / court / ceremonial purpose

mosaics found in rooms 30, 31 and 32

cold rooms with plunge bath (frigidarium)

warm room (tepidarium)

hot rooms with  
hot baths (caldarium)

remains extend to Vicarage garden
